TECHNICAL REPORT REMR CO-3

CASE HISTORIES OF CORPS BREAKWATER
AND JETTY STRUCTURES

Report 1
SOUTH PACIFIC DIVISION

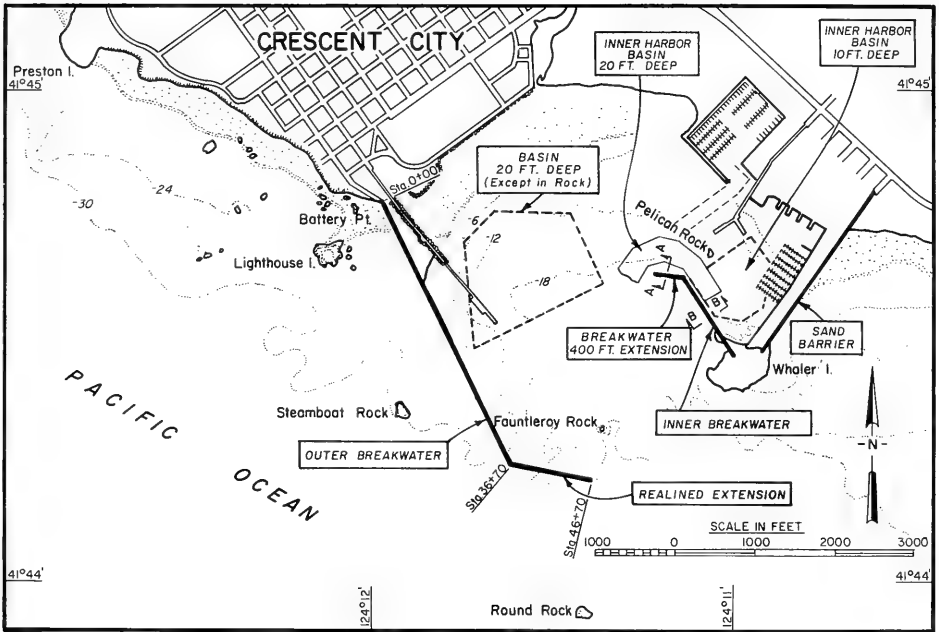
Figure 3. Crescent City Harbor, California

1946	Construction of a 1,200-ft-long inner breakwater was completed to provide protection to a small-craft basin. The inner breakwater extended from Whaler Island northwest (Figure 3). The crest el of the structure was +18 ft mllw (Figure 4) and 10- to 12-ton armor stones were utilized during construction.
1948	A 1,000-ft-long extension of the original (outer) breakwater extending toward Round Rock (Figure 3) was completed. Ten- to 12-ton armor stones were used.
1948-1949	During storms of 1948 and 1949, the 1,000-ft-long extension of the outer structure suffered considerable damage.
1950	The crest el of the entire outer breakwater, with the exception of a 300-ft segment (sta 12+50 to 15+50), was raised to +20 ft mllw with a 22-ft-wide concrete cap to prevent overtopping.
1950-1951	Winter storm seasons resulted in further damage to the outer breakwater. Damages consisted of displacement of the concrete cap and armor stones down to about 0.0 mllw in all of the extension located seaward of sta 37+00.

Date(s)	Construction and Rehabilitation History
1957	The 1,000-ft-long outer breakwater extension, as authorized in 1952, was completed. Twelve-ton stone protection was used from sta 36+70 to 41+20. From sta 41+20 to 46+70, 25-ton unreinforced tetrapods (1,836 units) were placed on the seaward slope (Figure 5). Model tests were conducted (US Army Engineer Waterways Experiment Station (WES), Hydraulics Laboratory (HL) 1953, 1956).
1957- 1964	Damages occurred to a portion (sta 36+70 to 41+20) of the outer breakwater, and in 1964 were repaired using 12-ton stones and 140 25-ton tetrapods. The tetrapods were not model tested for their adequacy for placement in this area, and they were destroyed over a period of years.
1973	Repairs were made to the concrete cap of the outer breakwater between sta 35+40 and 37+00.
1974	Rehabilitation of the outer breakwater between sta 34+70 to 37+00 was completed. Two layers of 40-ton unreinforced dolosse (246 units) were placed on the seaward slope.

1974	Construction of a 400-ft-long extension of the inner breakwater was completed (Figure 3). Model testing was conducted to determine optimum wave conditions (Senter and Brasfield 1968, Senter 1971).
1979	Repairs were made to the following reaches of the outer breakwater using 18- to 30-ton stone: sta 19+00 to 20+00, 22+00 to 24+00, 24+60 to 27+20, 28+90 to 29+50, 30+50 to 31+00, and 37+00 to 41+20. Repairs to sta 15+50 through 17+50 also were made using stone in the 14- to 25-ton range.
1983	Major storms in the winter of 1983 resulted in broken dolosse on the outer breakwater. Estimated damage to the structures was \$4,400,000.
1984	Approximately 23,300 tons of stone were placed to repair various sections of the outer breakwater between sta 17+30 to 33+90.
1986	The outer breakwater is presently in poor condition. The problem area is primarily between sta 34+70 through 37+00 where missing and/or damaged dolosse are apparent. A contract was issued to rehabilitate the dolosse section of the outer structure (sta 34+70 through 37+00) with 700 fiber-reinforced 42-ton dolosse. The dolos perimeter used special placement, and the dolosse on the outer portion of the seaward transition were entrenched and buttressed with 25-ton stone (Baumgartner, Carver, and Davidson 1985). About 80 of the constructed dolosse were stockpiled on the leeward side of the jetty for repair contingencies. This rehabilitation effort was also used to gather data on prototype forces on dolosse. Twenty of the dolosse (painted red) were instrumented and placed in the main dolos section at about sta 36+00. As of this date, no data have been received from the prototype dolos study.

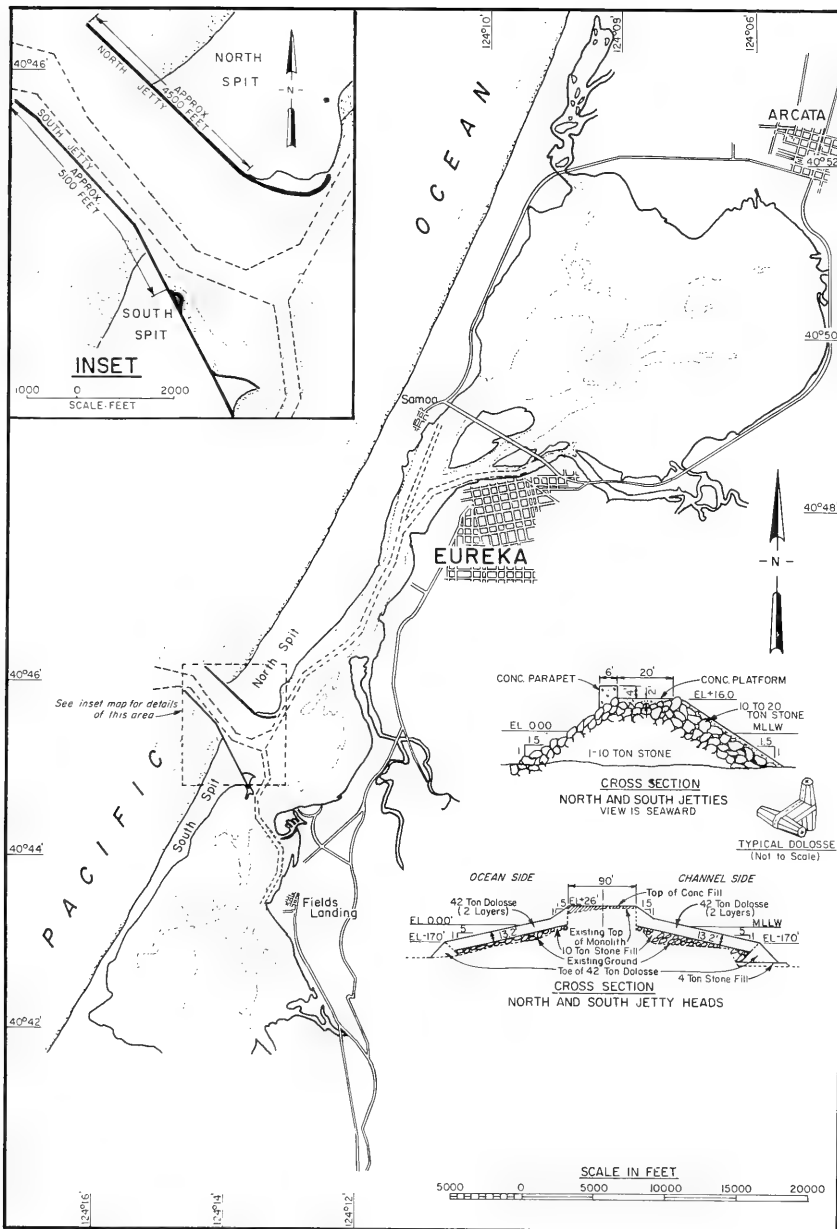
Figure 6. Humboldt Harbor and Bay, California

1937	South jetty repairs using 1,552 cu yd of concrete were completed at a cost of \$25,400.
1939	Heavy storms caused great damage to both jetties. The monoliths at the outer end of the south jetty were undermined, causing them to tilt and sink. Breaches occurred in the jetty immediately shoreward of the monolithic end. A partial breach occurred through the north jetty just shoreward of its monolithic end. In addition, considerable damage was done to the side slopes of both jetties. During the year south jetty repairs were completed using 12,450 cu yd of concrete at a cost of \$151,025.
1940	North jetty repairs using 7,418 cu yd of concrete and 2,200 tons of stone and south jetty repairs using 29,772 cu yd of concrete were completed at a cost of \$311,848.
1941	North jetty repairs using 15,158 cu yd of concrete and 1,705 tons of stone were completed at a cost of \$141,220.
1942	North jetty repairs using 8,809 cu yd of concrete were completed for a cost of \$124,220.

1957- 1958	Severe winter storms deteriorated the north and south jetties to such an extent that repair work constituted a major construction project.
1958	Mass concrete was poured to fill eroded areas on crests, and armor stones were replaced in areas that were breached and washed out. Concrete blocks (11 by 11 ft) weighing 100 tons and 12-ton tetrahedrons were placed on the heads of both jetties.
1959	Major side slope losses on the south sides of both the north and south jetties occurred.
1960- 1963	Rehabilitation of both jetties was accomplished. Jetty trunks were repaired with 12-ton stones placed on 1V:1.5H slopes in the eroded areas. Jetty heads were reconstructed using 20-ton blocks to form head perimeters, and centers were filled with mass concrete. Two-hundred and fifty 100-ton concrete blocks were placed around the seaward tip of the south jetty head. The concrete monolith at

Date(s)	Construction and Rehabilitation History
	seaward end of the north jetty was completed in 1961 and within the year was undermined by wave action resulting in part of the monolith breaking off. The monolith was repaired by placing rocks around the head section on 1V:2H side slopes and grouting the rocks with concrete. The elevation of the concrete at the north jetty was raised to +25 ft mllw and at the south jetty to +26 ft mllw at the tip. The heads were protected with 12-ton stones with a cover layer of 100-ton concrete blocks.
1963-1965	Winter storm waves washed away most of the newly placed 100-ton concrete blocks.
1969-1970	The concrete monolith at south jetty was undermined and broken. Heads of both jetties were totally destroyed.
1971-1972	Rehabilitation of both jetties was completed. Concrete monoliths were reconstructed, and 42-ton dolosse were placed around the seaward quadrant of both jetty heads. Four unreinforced, 1,271 steel-reinforced, and 17 steel-fiber-reinforced dolosse were placed on the north jetty; and 22 unreinforced and 1,423 steel-reinforced dolosse were placed on the south jetty head. Dolosse (43-ton) also were placed on the shoreward transition sections of both jetty heads. Two layers of dolosse were placed using a concentration of 11 dolosse per 1,000 sq ft of slope. Cost of this work was \$10,108,764. Model testing was conducted prior to these repairs (Davidson 1971).

1973	South jetty repairs using concrete and stone were completed at a cost of \$20,400.
1975	An earthquake of 5.2 magnitude on the Richter scale occurred near the site. Inspection trips subsequent to the earthquake revealed fresh cracks along the south jetty running along the edges of the crest and slope for a distance of about 800 ft on the channel side and 300 ft on the seaward side. Blowout holes also were observed at several locations on the south jetty. On the north jetty, three of the dolosse had moved about 50, 100, and 150 ft from the placement area, respectively. Only minor settling of the remaining dolosse had occurred, and no cracking or unraveling of the dolosse units was apparent.
1977	South jetty repairs using concrete and rock were completed. Approximately 15,000 tons of stone ranging from 1 to 20 tons were used for these repairs.
1977-1978	The jetties were subjected to severe storms combined with high tides and winds. On occasion, waves covered both jetties over their entire lengths. Waves also were observed breaking over the dolosse and concrete monoliths of the jetty heads. North jetty repairs using stone were completed at a cost of \$450,000.

Date(s)	Construction and Rehabilitation History
1978	An inspection revealed that the north jetty slope was eroded at several locations, and 12 blowout holes were apparent in the concrete cap. Also, at the north jetty head, waves had broken away a 20-ton concrete block from the concrete monolith which washed across the monolith and was resting against a tip of a dolos. The slope of the south jetty had eroded in numerous locations, and the parapet wall had broken at four stations. Nineteen blowout holes were observed in the south jetty concrete cap. Also a 7-ft stone had broken out of the parapet wall and was deposited on the concrete cap.
1983	Major storms resulted in an estimated \$2,000,000 in damages to the jetties.
1984	Repair of the south jetty consisting of 4,900 tons of 15- to 25-ton stones and replacement of 20-ton concrete blocks at the jetty head was completed. Also 16,665 tons of 15- to 25-ton stones and 16,665 tons of 18- to 31-ton stones were stockpiled on the harbor side of the jetty.

1985	Repair of the jetty heads was completed using a total of approximately 1,000 42-ton dolosse in various areas and the construction of toe berms.

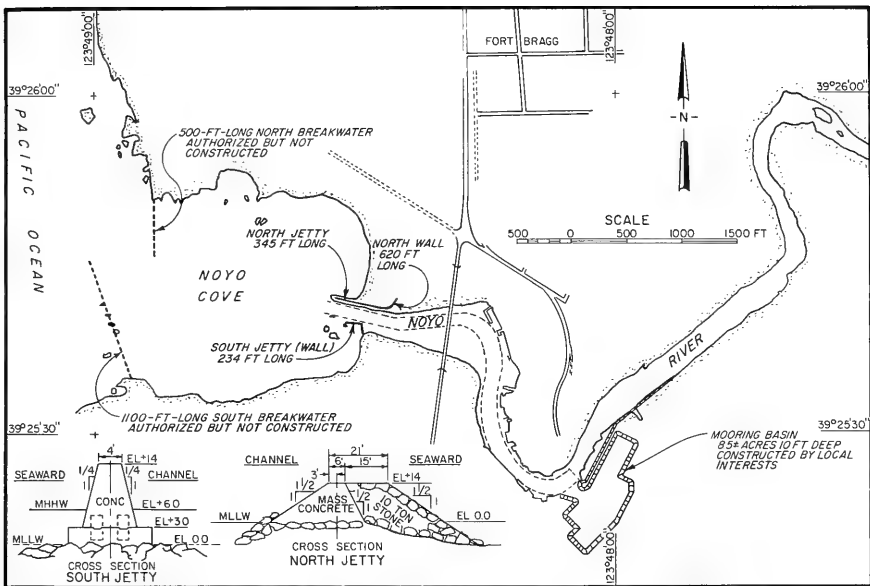
Figure 7. Noyo River and Harbor, California

<u>Date(s)</u>	<u>Construction and Rehabilitation History</u>
1924	Construction of two jetties across a sand bar was completed at the mouth of Noyo River. These were rubble-mound structures spaced approximately 125 ft apart. The initial lengths of the north and south jetties were 648 and 110 ft, respectively.
1931	Work at the Noyo River entrance, which included dredging, rock removal, and reconstruction of the jetties, was completed. The jetties were constructed to their present lengths (Figure 7). The north jetty was constructed of mass concrete. It was 345 ft long and connected to a 620-ft-long concrete wall. The south jetty was constructed 234 ft long with concrete. Both structures had crest elevations of +14 ft mllw.
1945	A 1,100-ft-long outer rubble-mound south breakwater was authorized (Figure 7). This structure has not been constructed.
1954	Stone (10-ton) was added to the seaward side of the north breakwater (Figures 7 and 8).

1961	Minor rehabilitation of the jetties and north wall was completed.
1962	A 500-ft-long outer rubble-mound north breakwater was authorized (Figure 7). This structure has not been constructed.
1970	The two outer breakwaters authorized by the Acts of 1945 and 1962 were reclassified from an active to inactive category. They were not economically feasible because of the high cost of construction and maintenance. Model testing of the structures was conducted (Wilson 1967).
1983	Restoration of the north jetty head was completed. Materials used consisted of approximately 2,500 tons of capstone, 10 cu yd of concrete, 1,500 cu yd of sandfill, and 4,100 tons of quarystone fill.
1986	The jetties are presently in good condition. Model testing currently is being conducted to optimize the location of a structure in the immediate area of the River entrance (Bottin, in preparation).

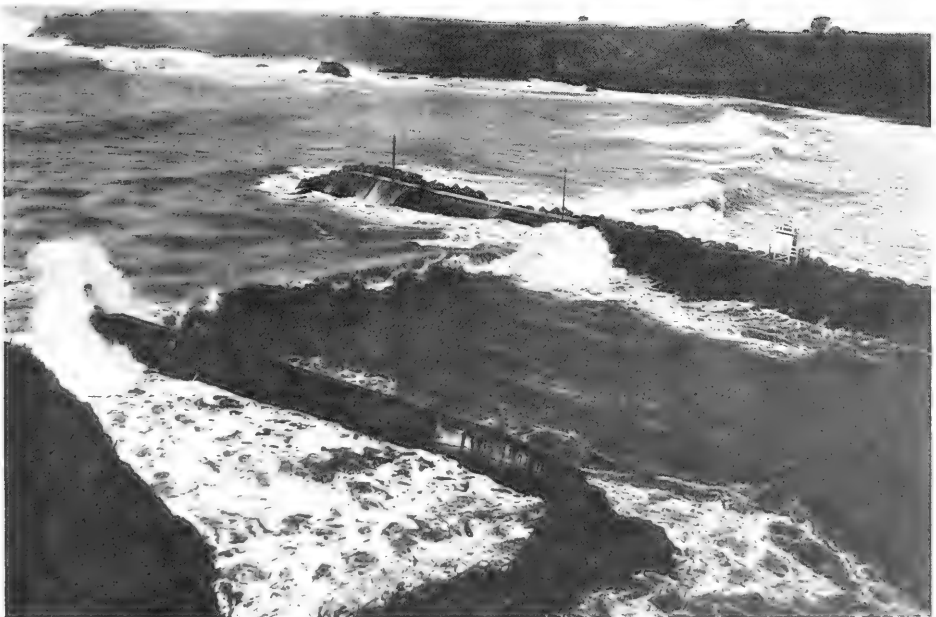
Figure 8. View of the jetties at Noyo River entrance

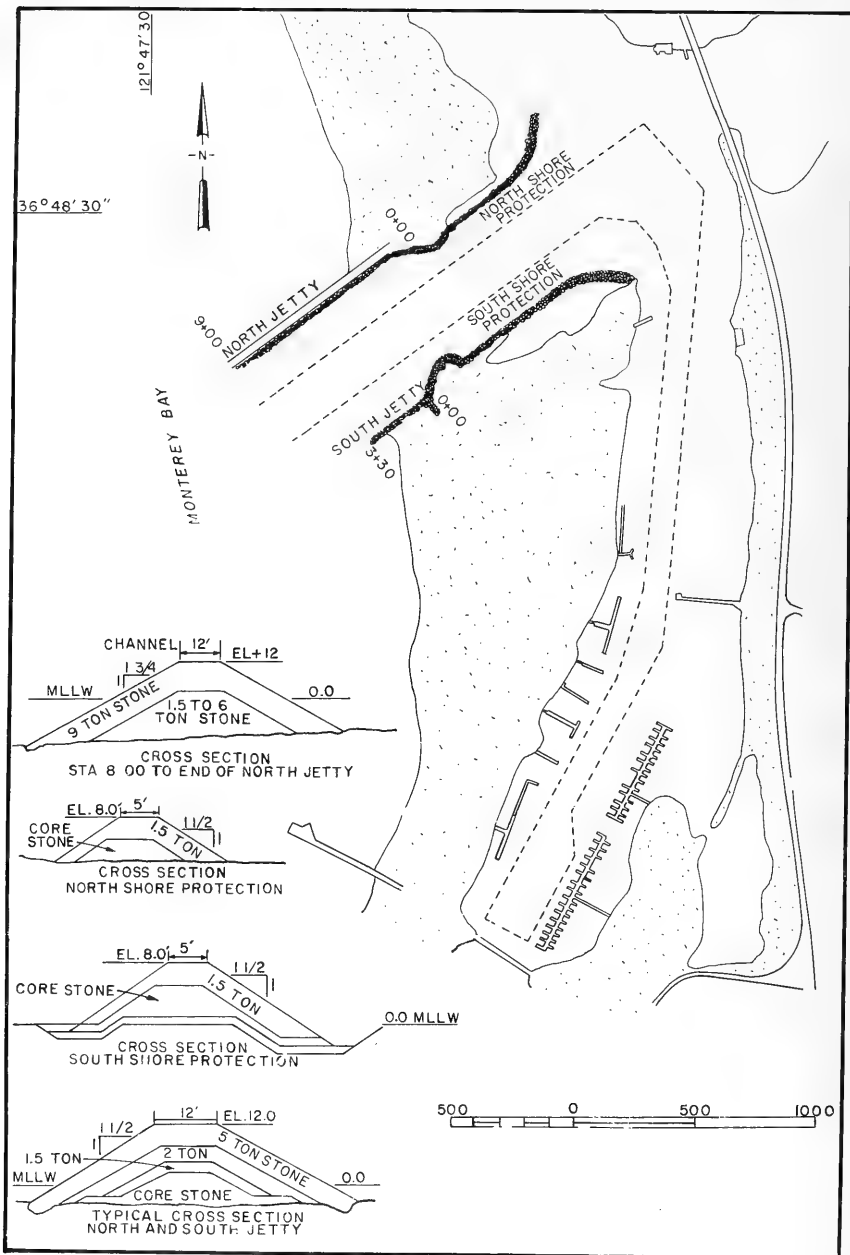
Figure 19. Moss Landing Harbor, California

1949- 1965	Severe erosion around the jetties and the unprotected shorelines adjacent to them was experienced during this time frame.
1966- 1967	Approximately 285 ft of the north jetty and the entire length of the south jetty were repaired. Also about 280 ft of curved revetment work was added to the north jetty and about 380 ft added to the south jetty. This work required the placement of 77,560 tons of stone. The north jetty head was not repaired because of the movement of the canyon head and the possibility that damage may occur to any repairs in that vicinity.
1975	A field inspection revealed the jetties in satisfactory condition except for damage on the seaward ends due to erosion and subsequent stone displacement. The deep submarine canyon head at the seaward end of the north jetty appeared to have stabilized.
1976	A basis for design of repairs to the jetties and revetment was prepared. Estimated cost of these repairs was \$290,000, and approximately 7,400 tons of stone would be required.

1986	Work is still required at the jetty heads. Except for the erosion at these locations, the jetties historically have performed satisfactorily and suffered relatively minor damages.

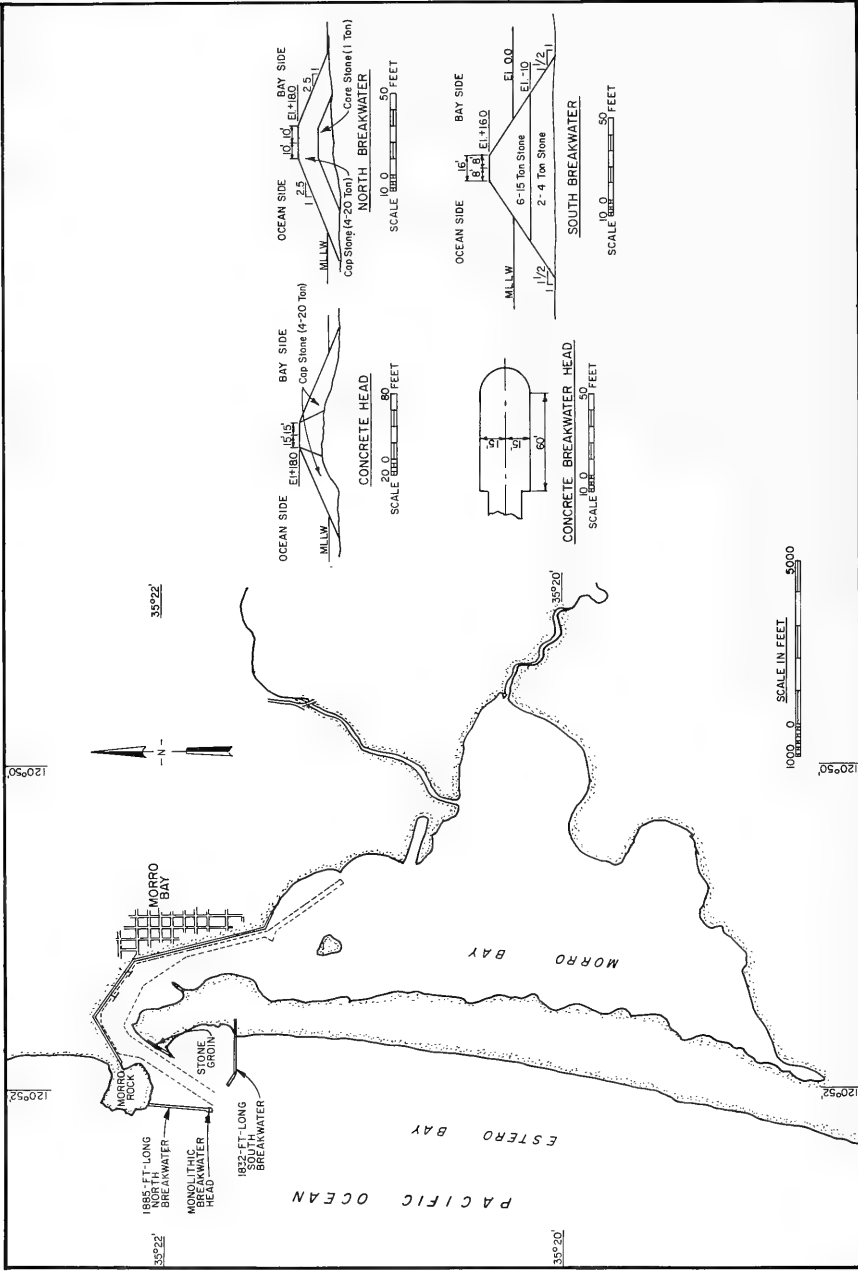
Figure 21. Morro Bay Harbor, California

Date(s)	Construction and Rehabilitation History
1942 1943	A 1,000-ft-long north breakwater was constructed, and a 1,832-ft-long south breakwater was completed at the site (Figure 21) to serve as a base for naval patrol craft. The structures were rubble-mound and built at an el of +16 ft mllw with 1V:1.5H side slopes and a crest width of 16 ft.
1943- 1944	Storm waves during this period damaged the north breakwater. The south breakwater received no appreciable damage.
1945	The north breakwater was repaired and extended to 1,800 ft in length. This work also included widening the crest from 16 to 20 ft. The project was adopted and completed under the supervision of the CE using funds provided by the US Navy.
1946	The north breakwater again suffered damage from storm waves.
1948	Maintenance work was performed on the north breakwater. Damaged sections of the structure were restored, and the cap was bound with concrete across the crest to an el of -2 ft mllw on both sides.

1949- 1960	The north breakwater continued to deteriorate, and shoaling occurred in the channels. The south breakwater still had suffered no observable damage since its construction in 1943.
1964	The north breakwater was reconstructed at a cost of \$1,561,882. The new rubble-mound structure was built at an el of +18 ft mllw, with a 20-ft-wide crest and 1V:2.5H side slopes. The structure was rebuilt about 100 ft bayward of the original north breakwater location and extended to 1,885 ft in length (Figure 21). The breakwater included larger armor stone than the original structure. Also included was a concrete monolithic breakwater head. Model tests were conducted (Jackson 1961).
1983	Major storms resulted in approximately \$1,430,000 in damages to the breakwaters.
1985	Maintenance repair of the north and south breakwaters was completed which included the placement of approximately 18,000 tons of capstone. Capstones ranged in weight from 6-21 tons each.

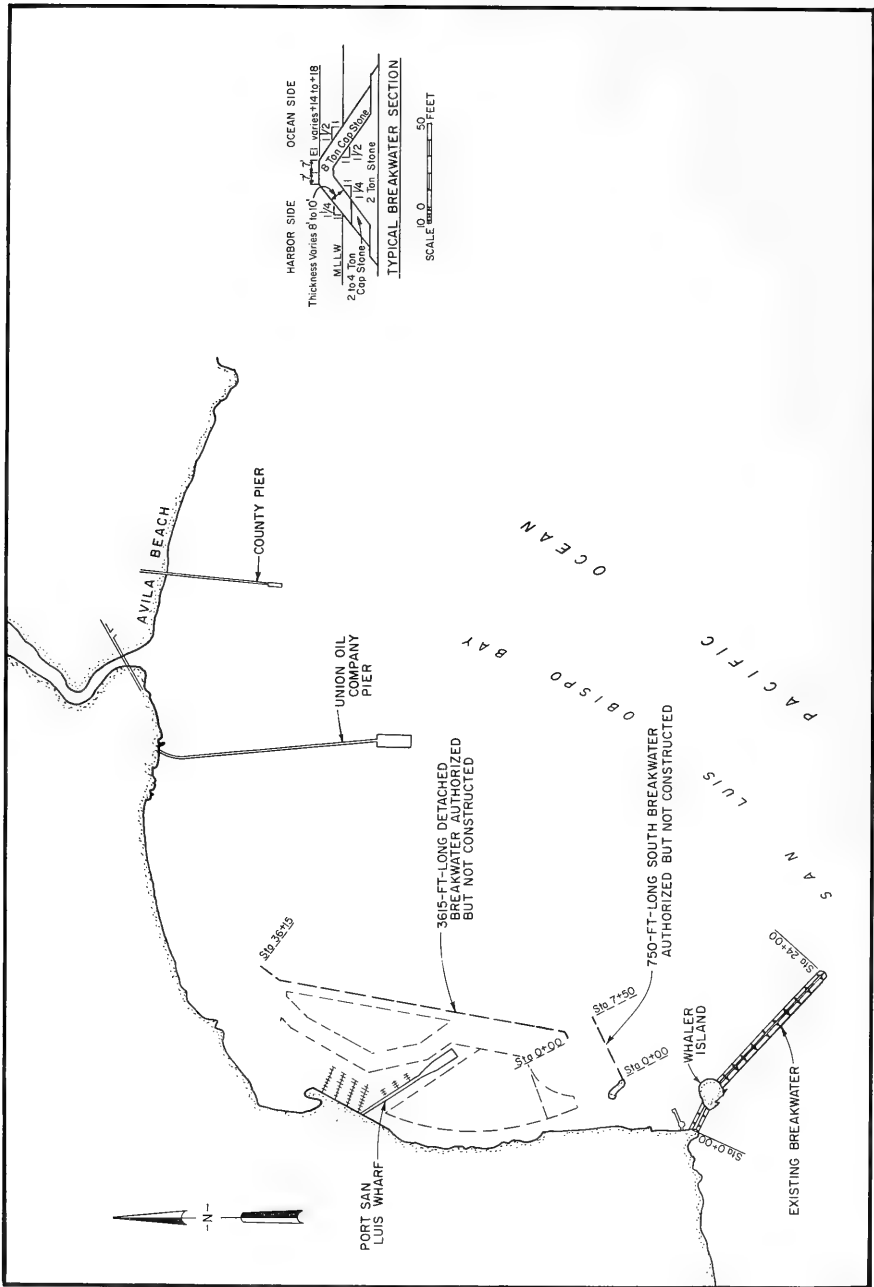
Figure 22. Port San Luis, California

Date(s)	Construction and Rehabilitation History
1888- 1913	Construction of a rubble-mound breakwater, approximately 2,400 ft long, was completed at the site (Figure 22) during this time frame. The crest el of the structure varies from +14 ft to +18 ft mllw with a 14-ft width. The side slopes are 1V:1.5H on the ocean side and 1V:1.25H on the harbor side.
1924	The structure was breached in a zone about 300 ft seaward of Whalers Island (Figure 22) by storm waves.
1927	The breach formed in 1924 was filled with a concrete cap.
1931	The concrete cap placed in 1927 was washed away because of storm wave activity. Also, the head of the breakwater was damaged.
1935	Repairs were made to damaged areas of the structure. The slopes in the damaged zones were covered with 14-ton stones to els of -10 to -15 ft mllw.
1976	Modification of the existing project was authorized. Included were a 750-ft-long south breakwater, a 3,615-ft-long detached breakwater, and dredging of associated channels and anchorage areas (Figure 22). These structures have not been constructed.

1983	Major storms resulted in approximately \$578,000 in damages to the breakwater.
1984	Maintenance repair of the existing breakwater was completed which consisted of approximately 8,700 tons of capstone placement and resetting of 40 existing capstone. The crest width of the structure was increased to 20 ft. Plans and specifications for construction of the modified project (authorized in 1976) were about 80 percent complete.
1986	The breakwater currently is in satisfactory condition.

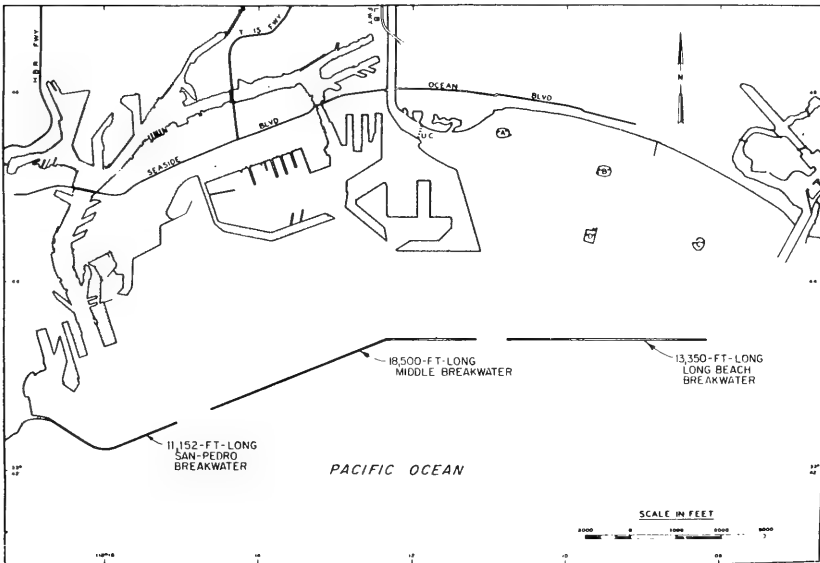
Figure 29. Los Angeles and Long Beach Harbors, California

1942- 1960	Construction of the 13,350-ft-long rubble-mound Long Beach Breakwater (Figure 29) occurred during this period. With the exception of the breakwater core el (Figure 30) the cross section of this structure was similar to that of the middle breakwater.
1947	Repairs to the middle breakwater were accomplished for a cost of \$786,700.
1983	Winter storms resulted in extensive damage to the San Pedro Breakwater. The structure was breached in an area immediately seaward of the curved portion of the breakwater. Model tests were conducted after the damage (Carver 1984, Baumgartner, et al. 1986), and restoration of the San Pedro Breakwater was subsequently completed. Work consisted of the placement of approximately 25,000 tons of salvage stone and new angular stones ranging from 15 to 25 tons each. Where voids occurred on the crest after this stone placement, concrete was pumped into flexible temporary forms to complete the repair.
